301 Green Gate Lane

Home Inspection Carolina
PO Box 77313
Charlotte, NC 28271
(704) 542-6575
HICarolina@carolina.rr.com
www.homeinspectioncarolina.com

301 Green Gate Lane
Charlotte, NC 28211

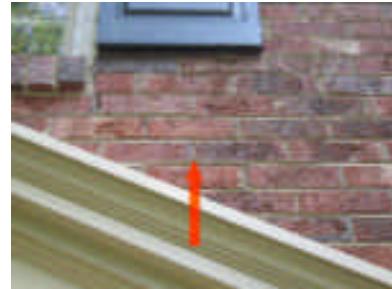
(a) There is a settlement cracked that needs to be pointed up (more mortar) above the front door, continue to monitor.

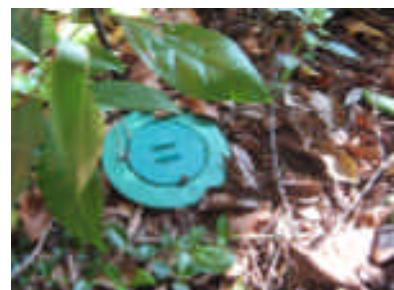
Note: This home has termite bait stations installed around the perimeter of the home.

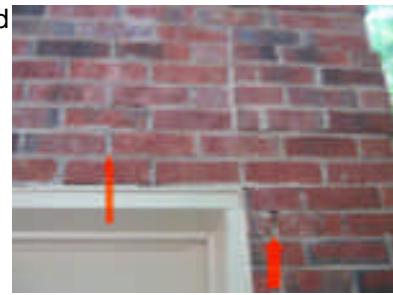
(d) There are minor settlement cracks that need to be pointed up (more mortar) above the right corners of the garage.

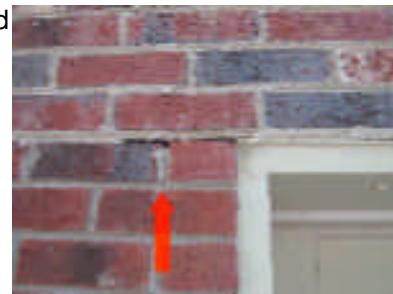
(e) There are minor settlement cracks that need to be pointed up (more mortar) above the left corners of the garage.

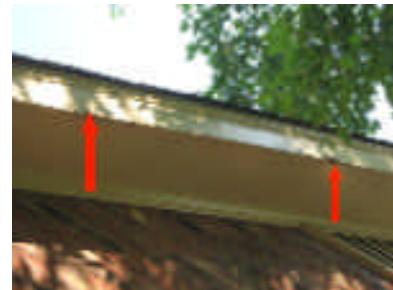
(a) The right side fascia has wood rot that needs repair.

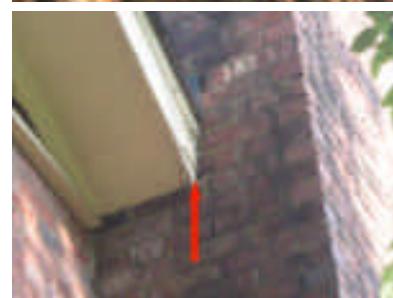
(b) There is wood rot that needs repair and sealant is needed where the fascia meets the right side brick chimney on both sides.

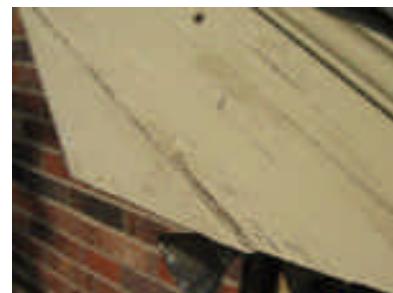
(c) The rear right corner 2nd story fascia is rotted and needs repair.

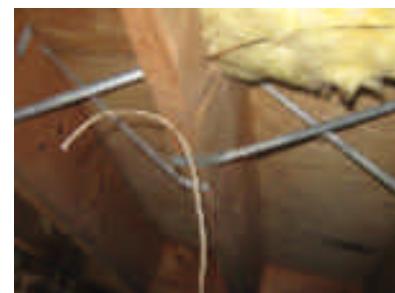
(b) Insulation is missing and needs to be installed at the rear right corner of the home.

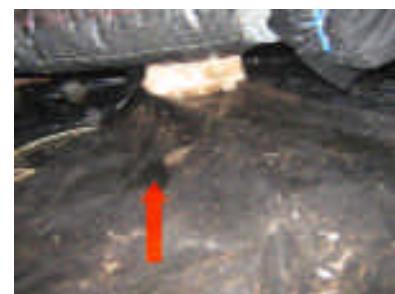
(d) There is standing water under the air ducts throughout the crawl space.

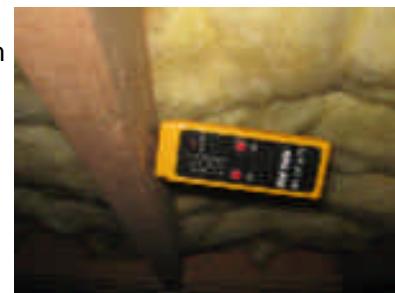
(e) There were moisture readings from 20% to 24% throughout the crawl space. Moisture from the air ducts is a contributing factor and adding a foundation vent fan will help circulate the air, helping dry out the crawl space.

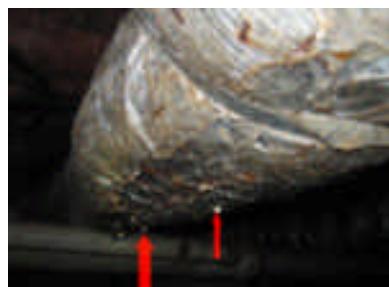
(h) There are heavy levels of moisture dripping off that air ducts in the crawl space. The temperature distribution may need to be adjusted or the ac unit is not functioning properly, have a licensed HVAC specialist evaluate and make repairs as needed.

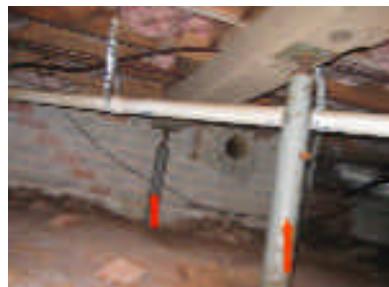
Note: There have been two support beams installed under the front or main part of the home. Has the seller the reason the additional support was installed, may want to have a licensed general contractor evaluate to ensure proper installation.

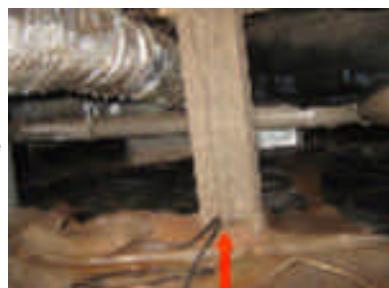
(i) There is a wooden support column installed under the middle of the home. There is earth to wood contact which is conducive for termites. The wood support column may need to be replaced with a concrete or metal column, have a licensed general contractor evaluate and make repairs as needed.

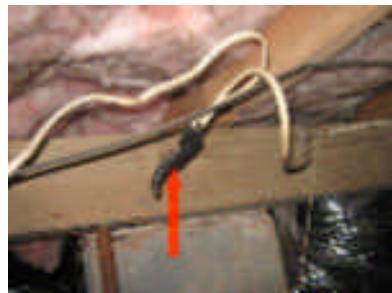
- (k) There are spliced wires that need to be installed in to a junction box.

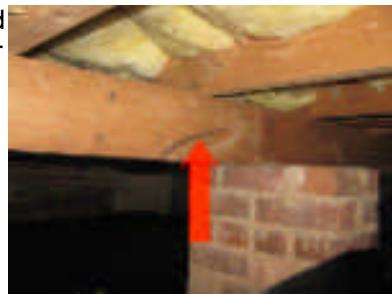
The floor joist support beam may be undersized and in need of additional support under the rear room where the pool table is located. The support beam is a 6x6 and may not be what is required. Recommend having a licensed general contractor evaluate and make repairs as needed.

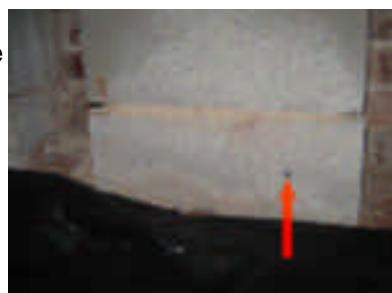
Note: There are signs of previous termite treatment in the crawl space by drill holes in the support columns and walls. The drill holes are used to spray termite treatment in the cinder block voids to treat all areas of the home and foundation that is touching the ground.

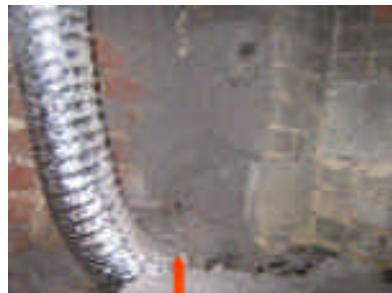
- (l) The dryer vent is not attached to an external exhaust and blowing lint into the crawl space repairs needed.

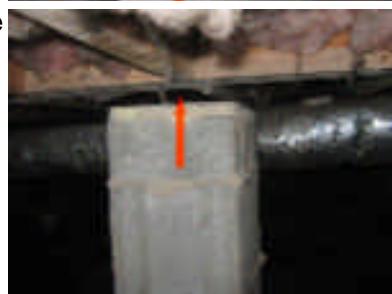
- (m) There is a column at the left side rear of the home that is not supporting a floor joist, may want to have a licensed general contractor evaluate and make repairs as needed.

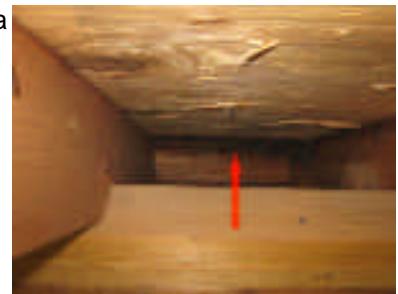
Signs of past/present leakage behind the fascia at the rear attic access behind the bonus room. Unable to determine if active leakage exists. Make inquiry with the seller as to the history of leaks.

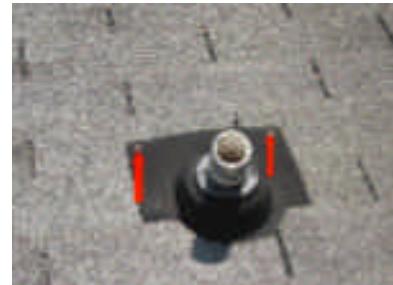
(a) There are exposed nails that need to be sealed at the exhaust boots.

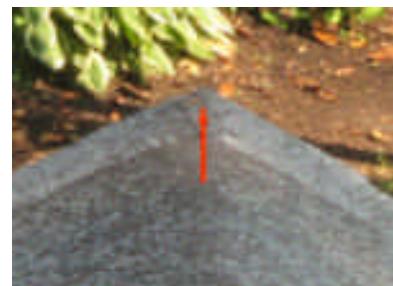
(b) There is a cracked shingle that needs to be repaired at the rear apex above the pool table room.

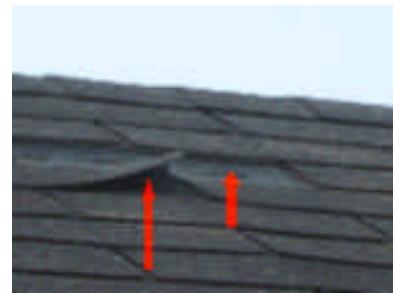
(c) There are several shingles that are missing, cracking or pop up from nail pops. May want to have a licensed roofer evaluate and make repairs as needed.

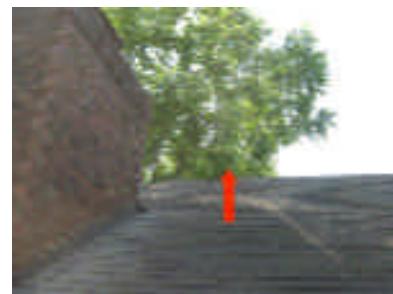
Trees are touching or overhanging the roof.
Damage is possible

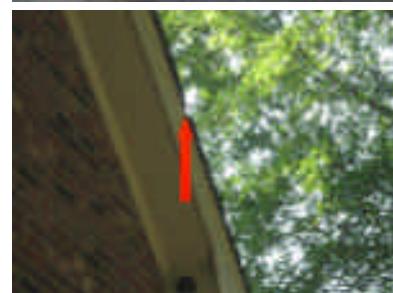
(d) There are cracked shingles along the left side roof edge that need repair or replacement.

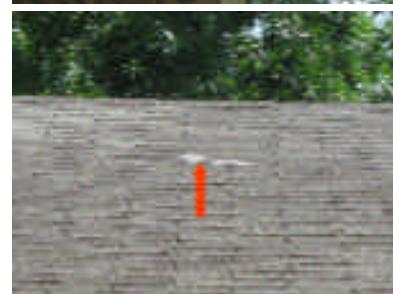
(e) There is a damaged shingle tab that needs repair above the garage area.

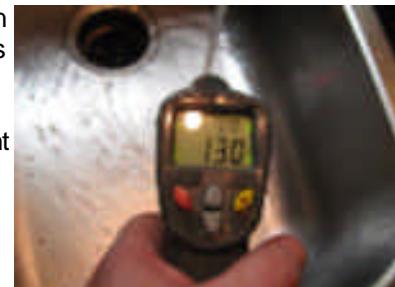
The water temperature at the time of inspection was 130 degrees. NOTE: Water temperatures above 125 degrees can burn or scald. If temperatures are above 125 degrees, it can easily be adjusted at the thermostat on the front of the water heater.

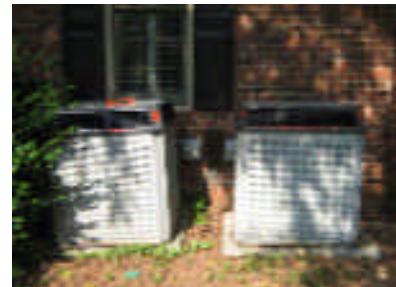
The unit needs to be leveled properly. The exterior AC units have lubricants that flow through the unit, if the unit is not level it will not be properly lubricated and may not work as efficiently.

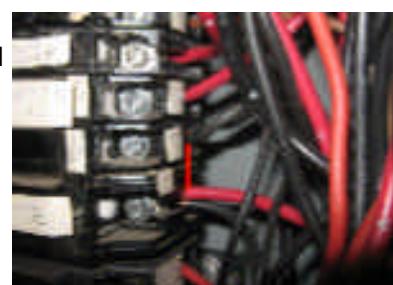
SUB PANEL NOTES: (8) Multiple wires are connected to a single lug on a circuit breaker where only one wire should be connected. Call a licensed electrician to further evaluate and repair.

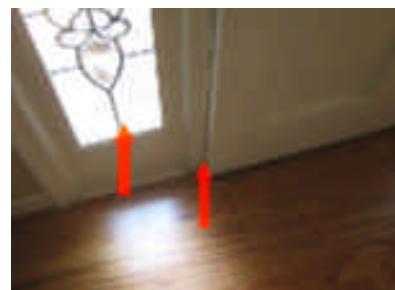
- (9) There is a crack at the bottom of the left sidelite at the front door and the front door rubs and needs adjustment at the bottom.

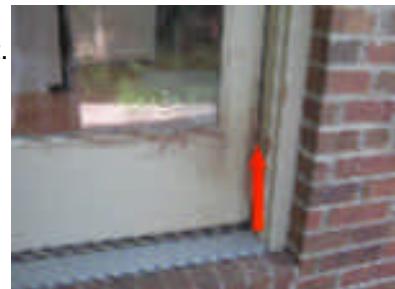
- (10) The rear door has damage from dogs and needs new weather stripping installed around it.

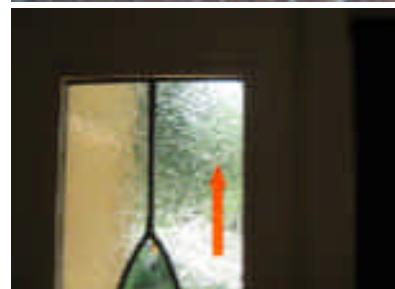
- (11) The top of the left sidelite is cracked and has a small hole, replacement needed.

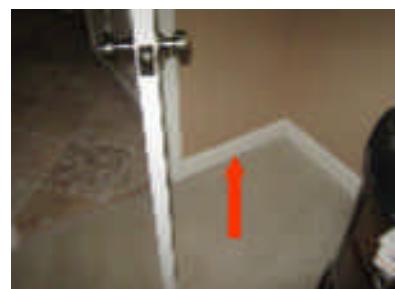
- (12) The door stop is missing behind the master bathroom door.

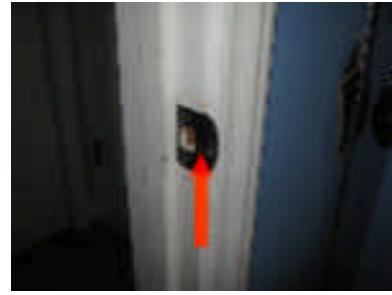
(14) The strike plate needs to be adjusted at the laundry room door.

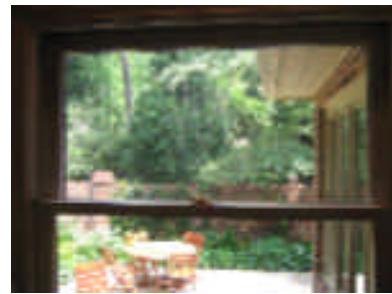
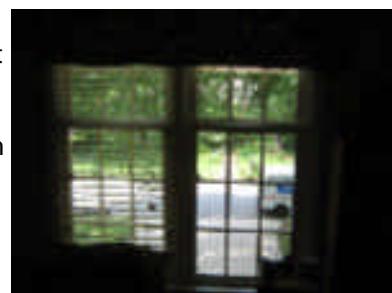
Many of the upper or lower sashes throughout the home are painted shut or would not open at the time of inspections. Not performing the function which intended. (Due to not being able to open the window a full inspection of the sash cords / counter springs could not be tested. Have the seller un-stick all the windows to prove that they function as intended before closing)

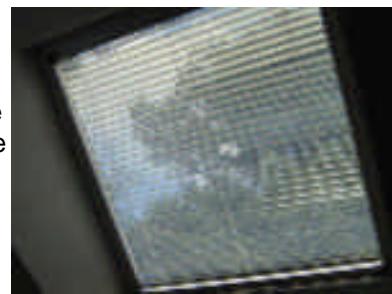
(16) The blinds were not functioning (opening or closing) at the time of inspection. They appear to be connected to a switch that opens and closes them. Ask the seller if the blinds are meant to open and close by a switch. If so have them open and close the blinds to ensure that they work properly. The Note: Unable to determine if the sky lights have broken seals due to them being dirty. Have the seller clean the windows to ensure that the seals are not broken.

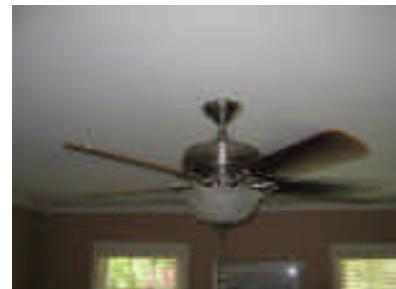
(17) The ceiling fan in the master needs to be balanced.

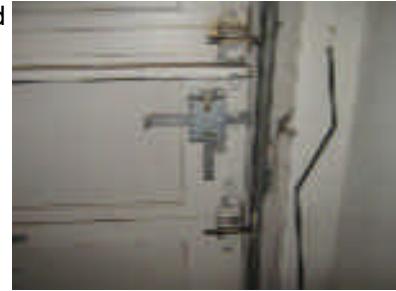
Attached, Two car. FYI - this home is equipped with an automatic garage door opener, yet the manual door locks are still installed. In many cases people manually lock them before going on vacation and forget when they return that they are locked. They hit the button by habit and cause damage to the door / opener because of the door still being locked. Recommend removing manual locking lever.

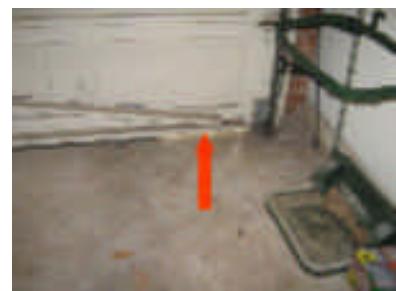
(18) Weather stripping is missing at the bottom left side of the garage door if facing the garage door from the exterior of the home.

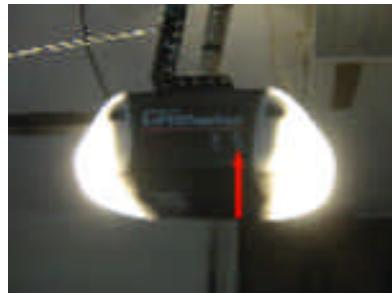
(19) ADJUST AUTO-REVERSE SWITCH ON GARAGE DOOR: Most electric garage door openers now have an auto-reverse feature which acts to stop and reverse the door should some object (a child) be encountered while the door is closing. It is a safety protection device and its proper adjustment should not be neglected. Adjustment screws are generally labeled and within easy reach with a screwdriver. These mechanisms should be finely adjusted so they will reverse upon contacting something soft, such as a child. Use a basketball, placed in the path of the closing door to test this function and adjust as needed.

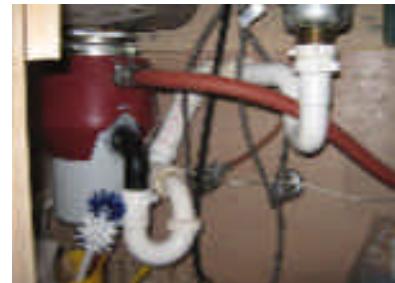
(21) An improper S-trap is noted, A licensed plumber should be called to make further evaluation and repairs as needed.

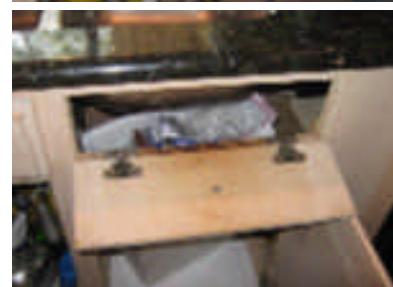
(22) The right side shelf is missing at the pull down draw under the kitchen sink.

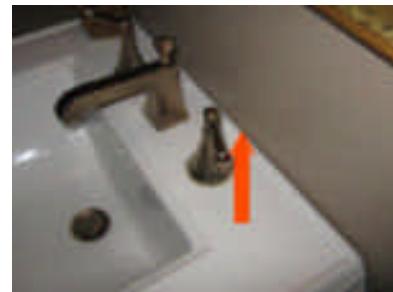
(a) Caulking and/or re-grouting is needed to prevent water intrusion along the back of the sink.

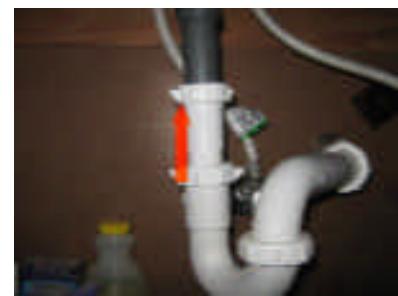
(a) The right sink has a minor leak, repairs needed.
