301 Green Gate Lane

Home Inspection Carolina
PO Box 77313
Charlotte, NC 28271
(704) 542-6575
HICarolina@carolina.rr.com
www.homeinspectioncarolina.com

301 Green Gate Lane
Charlotte, NC 28211

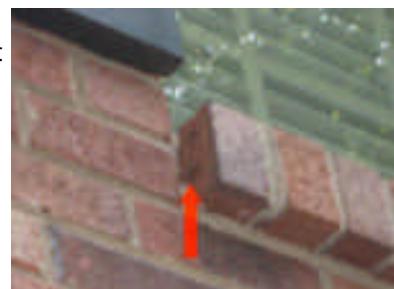
(b) The 2nd story window right of the front door needs to be pointed up (more mortar) at the left side of the exterior brick window sill.

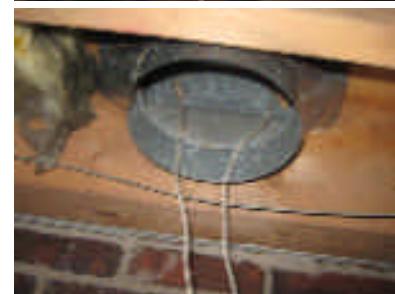
(c) The air duct is disconnected and needs to be re-attached at the rear right corner of the home.

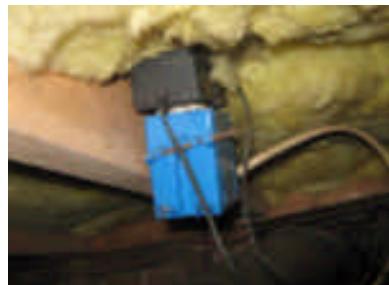
(f) There is a junction box that is installed upside down and needs to be capped at the rear left side of the home under the sunroom area, repairs needed.

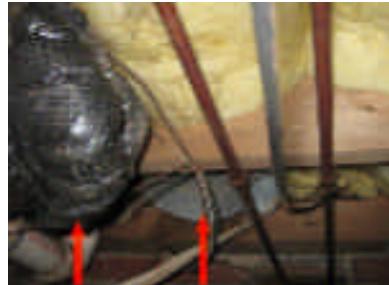
(g) Note: There is a air duct capped and a register boot that has been seal by the wood floor above under the left side of the room with the pool table.

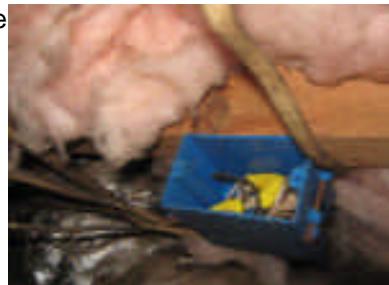
(j) There is a open junction box that needs to be capped at the rear middle of the main home crawl space.

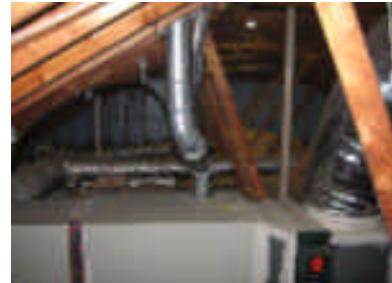
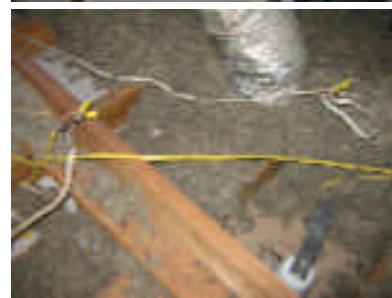
(a) There are spliced wires that need to be installed into a junction box at the rear right corner of the attic.

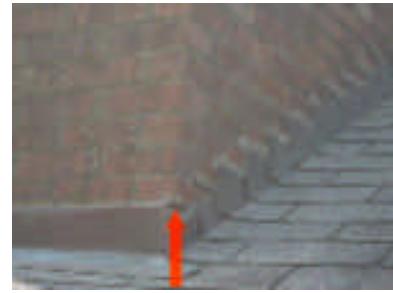
(f) The flashing needs to be sealed around the chimney.

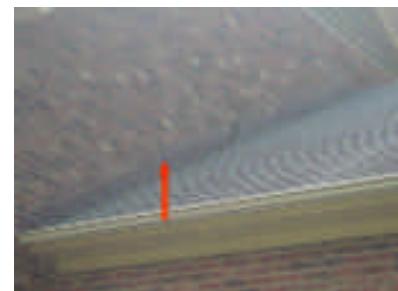
(g) The flashing needs to be sealed along the top of the garage roof where it meets the second story wall.

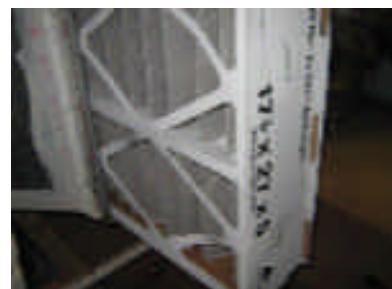
(6) Recommend replacing the air filters after moving in. Note: The air filter is a 17x27x5.

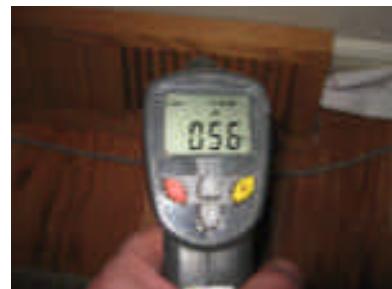
(7) The upstair unit is not producing an adequate air temperature drop. The temperature differentials should be between 15 and 20 degrees. The differentials were at 14 degrees. Further evaluation and repair or replacement will be needed by a qualified air conditioning contractor.

14 Degrees Upstairs - 17 Degrees Downstairs.

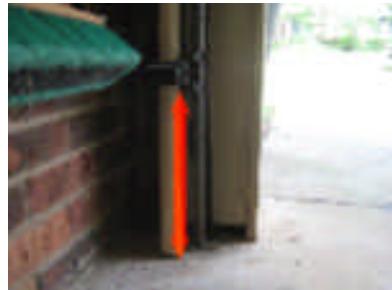
(20) The auto reverse sensors are installed to high off the ground and need to be installed 4 to 6 inches above the garage slab.

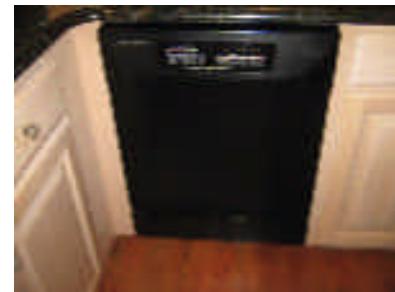
DISHWASHER:

CONDITION: Performing the function for which intended.

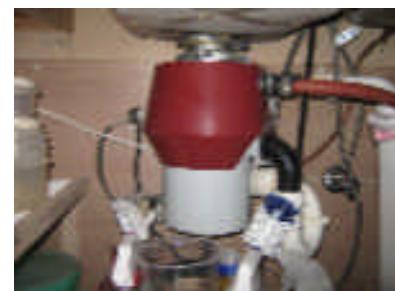
**GARBAGE DISPOSAL:**

CONDITION: Performing the function for which intended.

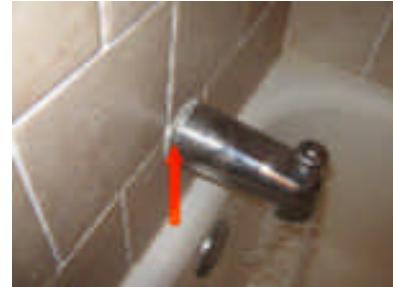
TUB/SHOWER PLUMBING FIXTURES:

(a) Caulking and/or re-grouting is needed to prevent water intrusion around the base of the tub faucet.

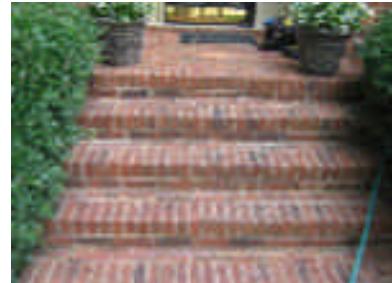
EXTERIOR STAIRS/STOOPS:

CONDITION: (26) The mortar joints need pointing up at the front steps.
